CITY OF BALTIMORE WET WEATHER CONSENT DECREE SMOKE AND DYED WATER TESTING FORM		Page 1 of 4
Sewershed: Low Level Subsewershed: 41	Company: REI/DRAYCO	Date: 07/28/2008
Test Type: Smoke	Ground Condition: Dry: X Damp: _ Wet: _	Supervisor: E.R. Crew: 4
Manhole ID: S13G1_011MH	Test ID: 1029-502	Notifications Made: __X__ Resident, Fire, 311
Field Sketch: (Show all manholes with numbers, blower placement location, sandbag or isolation locations, street names, building addresses and locations, defect locations and photograph numbers)

CITY OF BALTIMORE
SMOKE TESTING OBSERVATION SUMMARY
LOW LEVEL SEWERSHED
BALTIMORE CITY PROJECT 1029
REI/DRAYCO

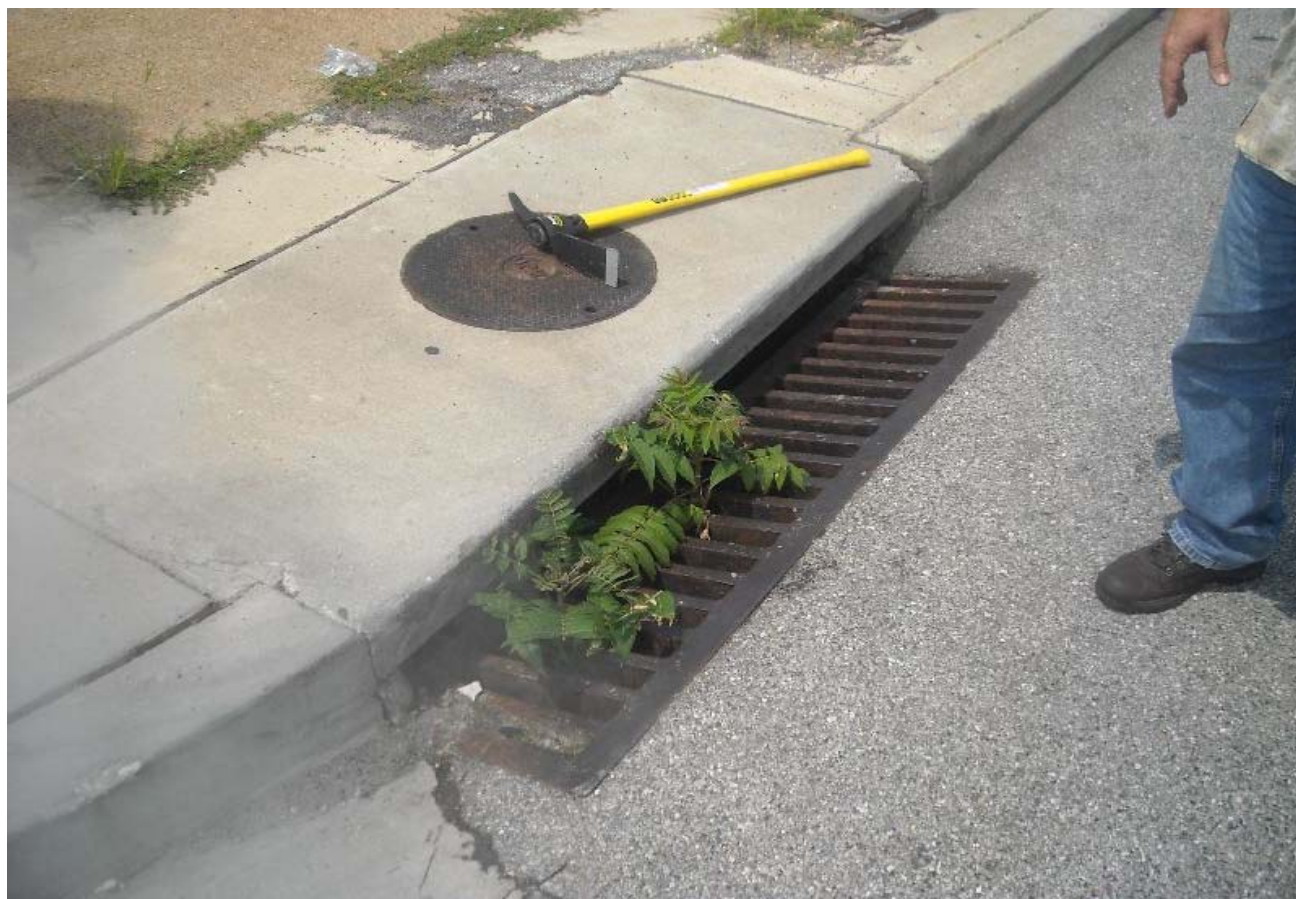
Photograph No: OB01-01
Filename: 1029-502_OB01-01.jpg

Unique Test ID: 502	Date: 07/28/2008	Basin: LL - 41	Manhole ID: S13G1_011MH
Defect No: OB01	Supervisor: E.R.	Crew: 4	Dye Test Recommended: N
Address: ATCO AVE. AT WASHINGTON BLVD.			
Source Type: 12 Catch Basin		Location: 06 Curb	
Sector: 01 Public		Severity: 03 Moderate	Drainage Area: 100
Comments: SMOKE COMING FROM CATCH BASIN AT ATCO AVE. AND WASHINGTON BLVD.

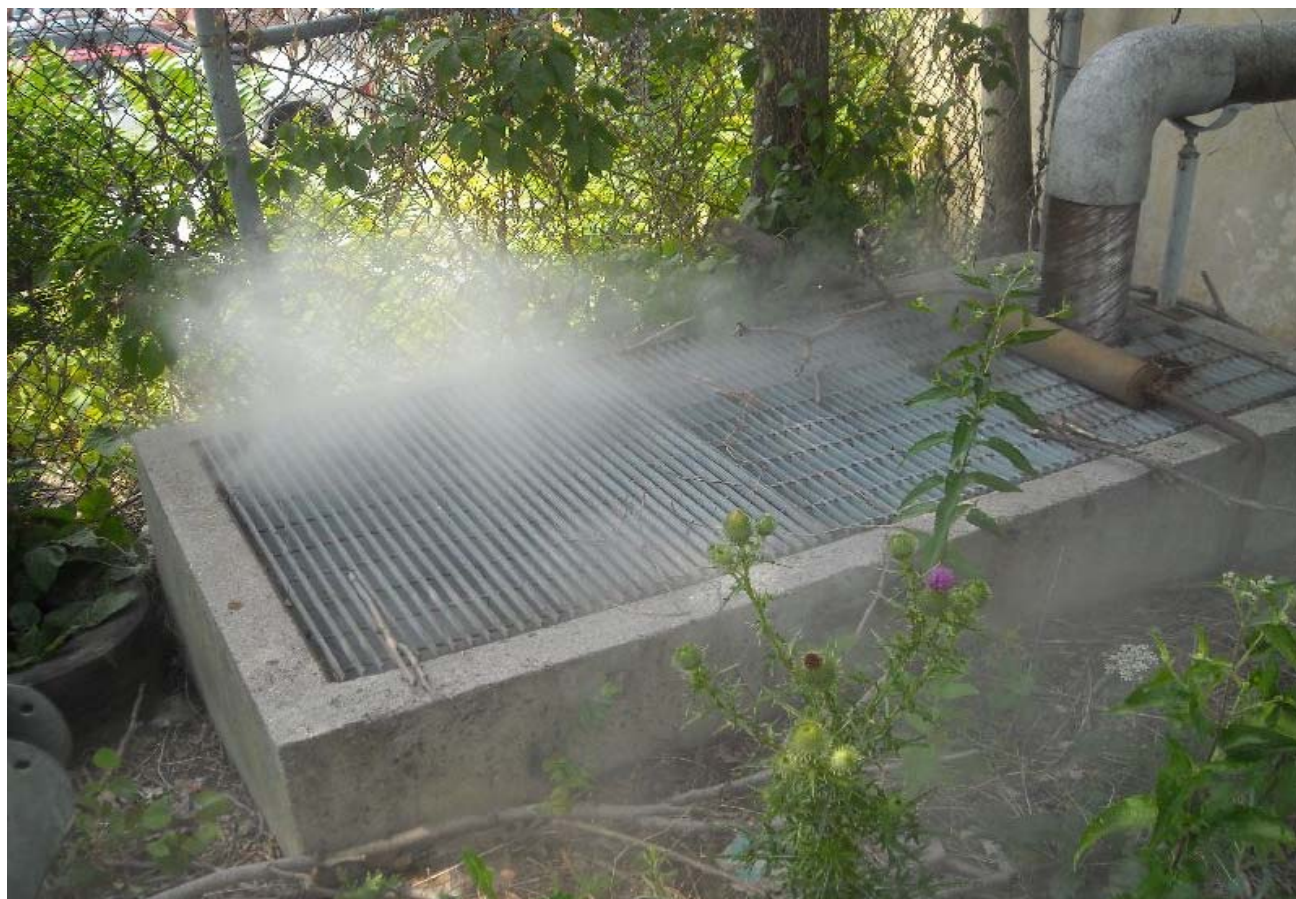
Photograph No: OB02-01
Filename: 1029-502_OB02-01.jpg

Unique Test ID: 502	Date: 07/28/2008	Basin: LL - 41	Manhole ID: S13G1_011MH
Defect No: OB02	Supervisor: E.R.	Crew: 4	Dye Test Recommended: N
Address: 3010 WASHINGTON BLVD.			
Source Type: 18 Other		Location: 07 Yard - Front	
Sector: 02 Private		Severity: 03 Moderate	Drainage Area: 35
Comments: SMOKE COMING FROM THIS STRUCTURE AT 3010 WASHINGTON BLVD.
